Presentation of the successful crossing by the “Federica” TBM of a geological accident in Saint-Martin-la-Porte construction site

F. Gamba
Alpina S.p.A./Egis

ABSTRACT: The 57.5 km long Mont Cenis Base Tunnel will link up Saint-Jean-de-Maurienne in France to the Susa plain in Italy. In 2015 additional exploratory work was launched from the Saint-Martin-la-Porte decline access tunnel. This included TBM excavation of a 9 km stretch of the southern tube of the Base Tunnel linking the existing access tunnels of Saint-Martin-la-Porte and La Praz. The purpose of this work was in part to check assumptions related to the geology and to acquire the experience required to excavate the Base Tunnel by means of a TBM through the Briançonnais Houiller zone. After excavating close to 300 metres, the TBM encountered a significant geological accident which disrupted progress and required adaptation work to be carried out. The geological context is presented along with the characteristics of the TBM. The major stages which enabled the geological accident to be successfully overcome will then be detailed along with the significant milestones involved in crossing the fault and the means used to stren

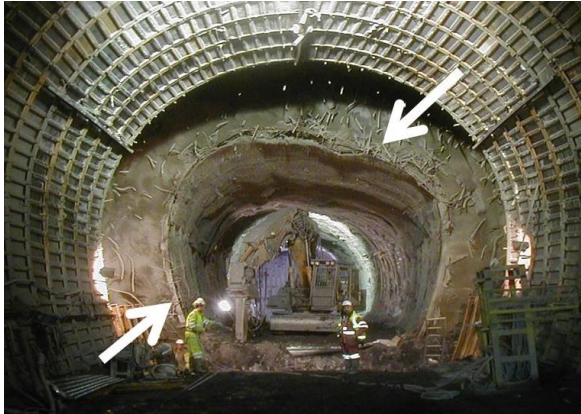
Figure 2. Convergence problems encountered in the Saint-Martin-la-Porte access tunnel.

The findings from access tunnel excavation work showed the specific and complex nature of a particular geological formation encountered when boring the Saint-Martin-la-Porte access tunnel. Initial work at the Saint-Martin-La-Porte site in Savoy took place between 2003 and 2010 with the construction of a 2,380-metre-long decline access tunnel. Boring work related to this access tunnel encountered quite exceptional difficulties when crossing the so-called “Productive” Houiller terrain. These difficulties come

in the form of very high amplitude convergence phenomena in a sector in which the thickness of the overburden terrain was moderate, less than 300 metres (fig.2).

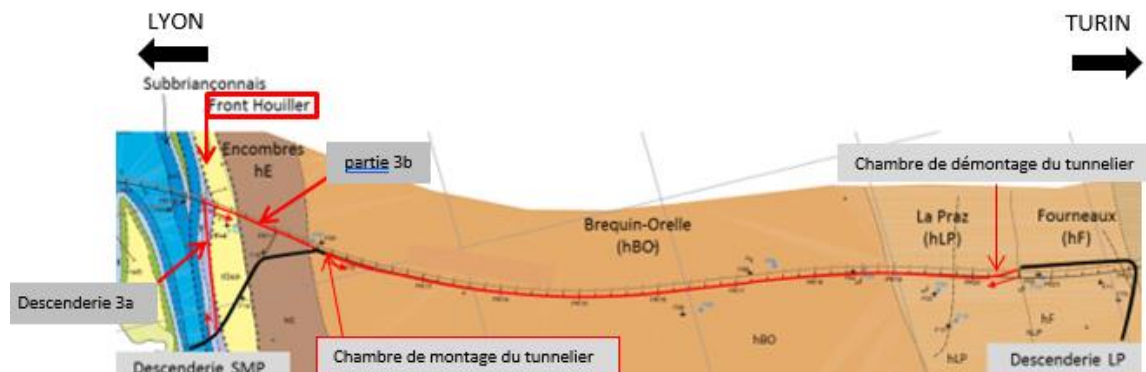
Figure 4. Geological context

Exploratory work on this site aims at improving geological, hydrogeological, geomechanical and geotechnical knowledge of the sector. Figure 4 shows the projected geological context of SMP4 structures.

The Saint-Martin-la-Porte access tunnel sector is characterised by the Briançonnais Houiller zone overlapping the sub-briançonnais zone by means of the Houiller Face, a tectonic accident made up of hectometric anhydrite layers at the tunnel level.

The excavation of part 3b, using conventional methods, crosses the last carbonated formations of the sub-briançonnaise unit (mostly limestone, calcareous shale and dolomites) then the anhydrites of the Houiller Face before entering the so-called Productive Houiller unit (Encombres hE Unit). The latter is characterised by a predominance of schists and carbonaceous facies (60%) as well as sandstone facies (25%) and a significant proportion of tectonised crushed levels (15%). These formations usually appear without continuity and in a highly disrupted structure giving rise to major convergence phenomena requiring specific systems to control deformations and stabilise the structure as well as protect the resources implemented.

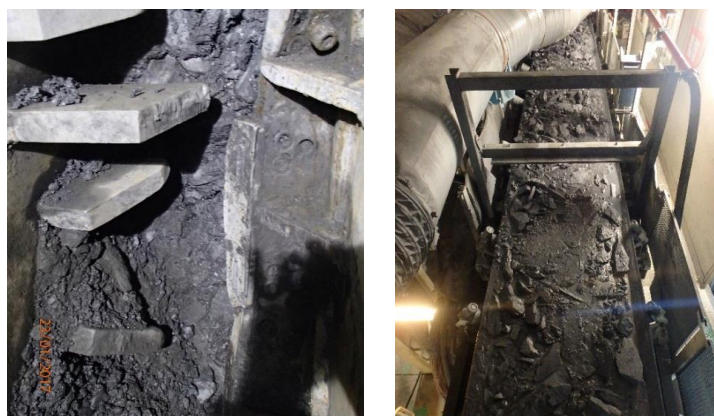
Figure 5. Materials encountered

Face surveys were carried out on the lower part of the TBM's cutting wheel: the face can be partially observed through the peripheral openings used to evacuate the spoil. The predominant lithologies observed before PK 12+085 comprise sandstones and, to a lesser extent, black schists, black carbonaceous schists and coal (fig. 5).

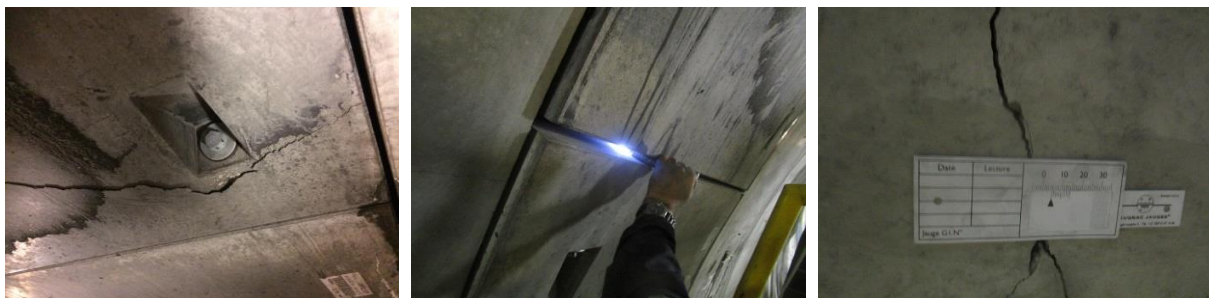
Figure 8. Phenomena observed on the support

Several phenomena were observed on the support (mismatching between rings, millimetric cracks, concrete fragments from the lining segments, deformations and oval-shaping of lining segments) at the rear of the TBM up to PK 12+075, i.e. 30 m before the cutting wheel stopped in the fault at PK 12+ 105 (fig. 8). The large volumes withdrawn actually caused a broad destructuring of the zone and the force was carried over to the lining segments to the rear of the TBM, in the terrain already excavated.

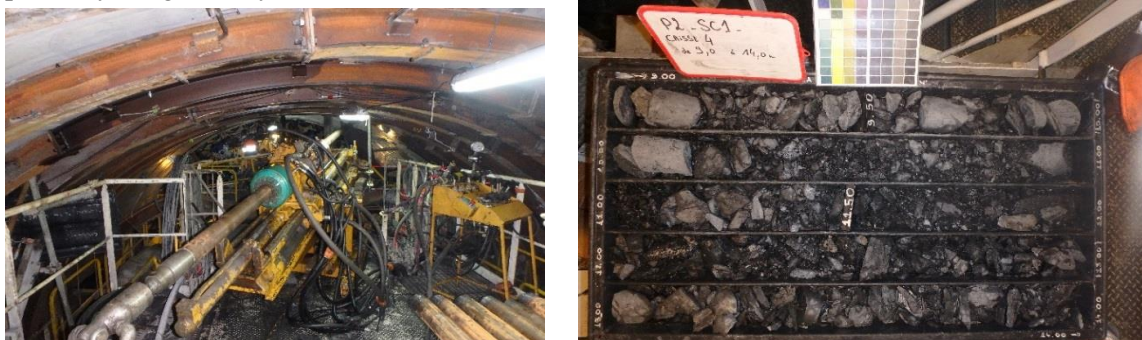
Figure 10. Non-destructive soil investigation workshop and example of core materials extracted

An additional rig installed on a gateway at the rear of the shield enabled areolar surveys to define more precisely the geometry of the fault and check the possible presence of empty spaces (fig. 10).
